**Flood Control Project Maintenance  
Levee Inspections**

**Fall 2014 Levee Maintenance Deficiency Summary Report**

**Flood Control Project Maintenance  
Levee Inspections**  
**LMA District Cover Sheet**  
**Fall 2014 Levee Inspection Results**

**Reclamation District No. 0544 Upper Roberts Island**

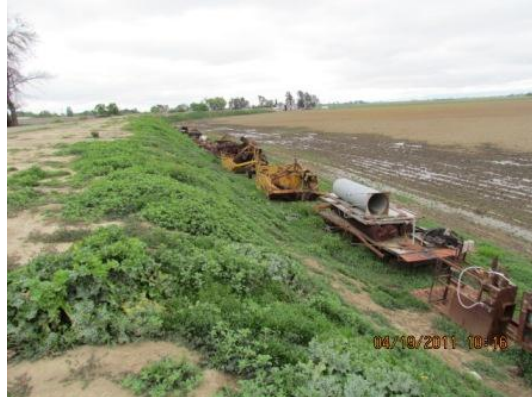
Photo 2 of 2 : FA\_2014\_RD0544\_108\_4\_20141020\_00004.jpg

Looking south at equipment along landside toe.

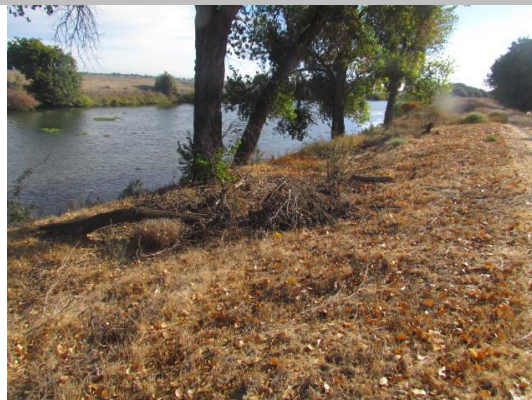
Photo 1 of 1 : FA\_2014\_RD0544\_108\_6\_20141023\_00055.jpg

LM Start	0.45	Rating **	M	Issue No.	6
LM End	0.45	Issue Type +	Ma	Location *	WS
Category	Earthen Levee			GPS Latitude/Longitude	
				Start	End
Item	Encroachments			37.864713 °	37.864713 °
				-121.326708 °	-121.326708 °
DWR ID	DWR_RD0544_01_f_2013_6				
Action/Comments					
Prunings					
Inspector Comments: Broken tree limbs on waterward slope and berm.

Looking southeast at tree branch on waterward slope.

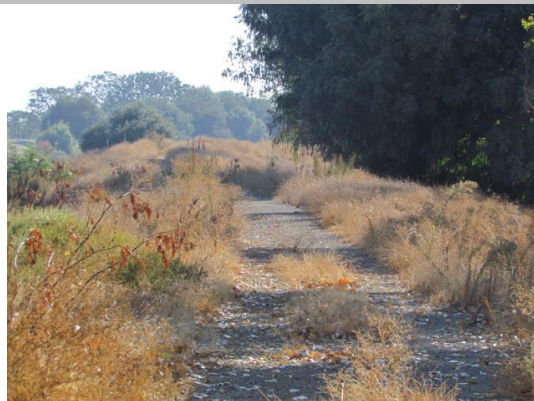
Photo 2 of 2 : FA\_2014\_RD0544\_108\_3\_20141020\_00002.jpg

Looking south at overgrown on landward and waterward slopes.

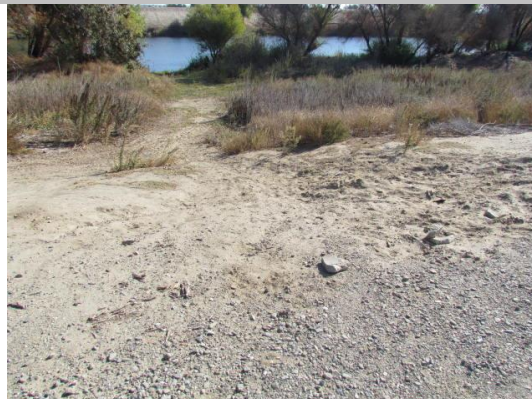
Photo 1 of 2 : FA\_2014\_RD0544\_108\_64\_20141020\_00032.jpg

LM Start	1.56	Rating **	M	Issue No.	64
LM End	1.56	Issue Type +	Ma	Location *	WS
Category	Earthen Levee			GPS Latitude/Longitude	
				Start	End
Item	Slope Stability			37.854081 °	37.854081 °
				-121.321268 °	-121.321268 °
DWR ID	DWR_RD0544_01_f_2013_64				
Action/Comments					
Repair the levee slope damaged by vehicle traffic and prevent access where possible.					
Inspector Comments: Damaged levee slope due to fishermen using slope as a ramp.

Looking east at damaged waterward slope.

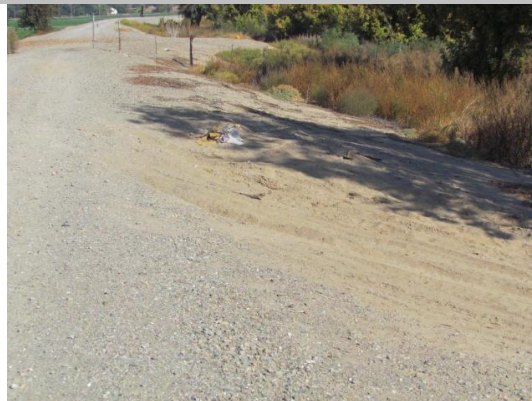
Photo 2 of 2 : FA\_2014\_RD0544\_108\_64\_20141020\_00033.jpg

Looking northeast at waterward slope.

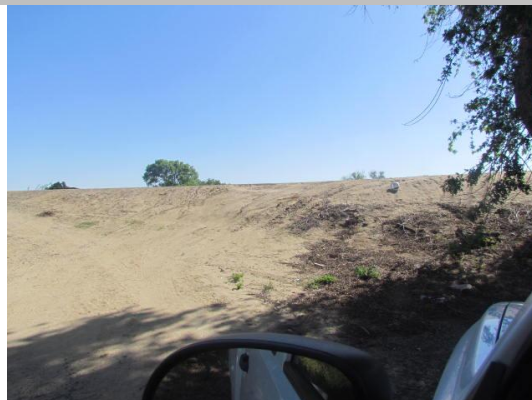
Photo 1 of 1 : FA\_2014\_RD0544\_108\_5\_20141020\_00005.jpg

LM Start	1.83	Rating **	M	Issue No.	5
LM End	1.83	Issue Type +	Ma	Location *	LS
Category	Earthen Levee			GPS Latitude/Longitude	
				Start	End
Item	Slope Stability			37.853188 °	37.853188 °
				-121.324145 °	-121.324145 °
DWR ID	DWR_RD0544_01_s_2013_5				
Action/Comments					
Repair the levee slope damaged by vehicle traffic and prevent access where possible.					
Inspector Comments: Slope damaged by vehicle traffic.

Looking east at landward slope damaged by vehicle traffic.

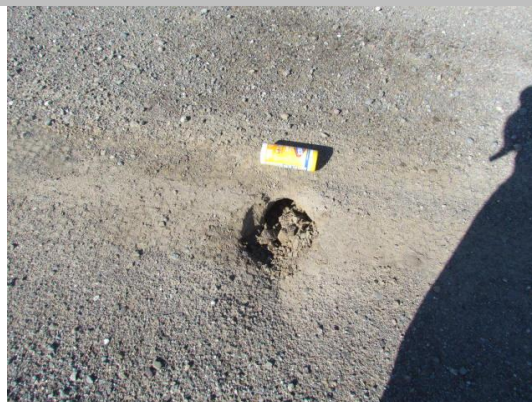
Photo 1 of 2 : FA\_2014\_RD0544\_108\_90\_20141020\_00042.jpg

Looking at rodent hole on levee crown.

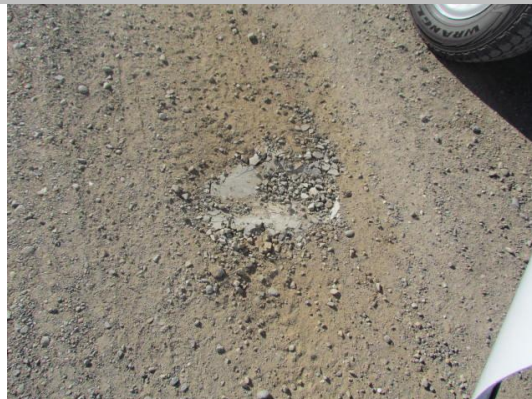
Photo 2 of 2 : FA\_2014\_RD0544\_108\_90\_20141023\_00058.jpg

Looking at grouted rodent hole on levee crown.

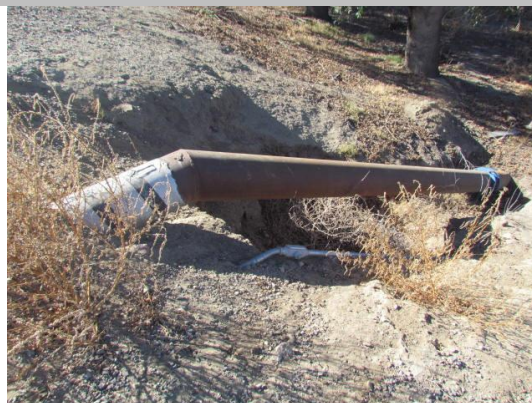
Photo 1 of 3 : FA\_2014\_RD0544\_108\_23\_20141023\_00059.jpg

LM Start	2.28	Rating **	U	Issue No.	23
LM End	2.28	Issue Type +	Ma	Location *	LS
Category	Earthen Levee			GPS Latitude/Longitude	
				Start	End
Item	Erosion / Bank Caving			37.847985 °	37.847985 °
				-121.324837 °	-121.324837 °
DWR ID	DWR_RD0544_01_s_2012_23				
Action/Comments					
Schedule repair of erosion site prior to the next inspection. Inspector Comments: Caving/erosion around irrigation pipe on landside slope.

Looking south at erosion around irrigation pipe on landside slope. (Fall 2014)

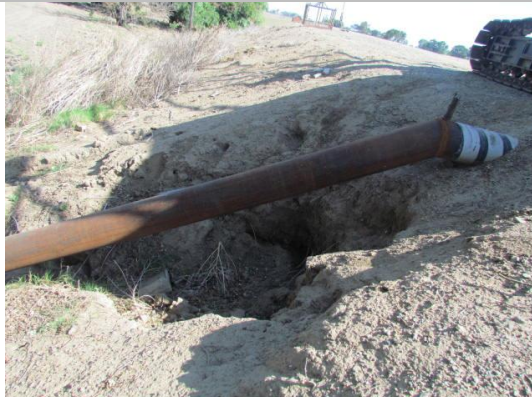
Photo 2 of 3 : FA\_2014\_RD0544\_108\_23\_20141020\_00019.jpg

LM Start	2.28	Rating **	U	Issue No.	23 (cont)
LM End	2.28	Issue Type +	Ma	Location *	LS
Category	Earthen Levee			GPS Latitude/Longitude	
				Start	End
Item	Erosion / Bank Caving			37.847985 °	37.847985 °
				-121.324837 °	-121.324837 °
DWR ID	DWR_RD0544_01_s _ 2012_23				
Action/Comments					
Schedule repair of erosion site prior to the next inspection. Inspector Comments: Caving/erosion around irrigation pipe on landside slope.

Looking north at erosion under irrigation pipe on landside slope.

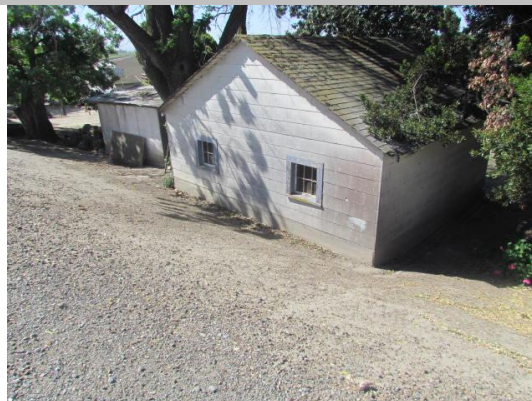
Photo 1 of 1 : FA\_2014\_RD0544\_108\_67\_20141020\_00034.jpg

Looking southeast at building at landward toe.

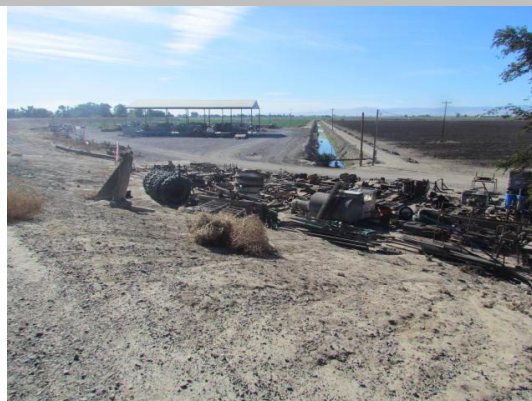
Photo 1 of 1 : FA\_2014\_RD0544\_108\_68\_20141023\_00060.jpg

Looking west at equipment at landward toe.

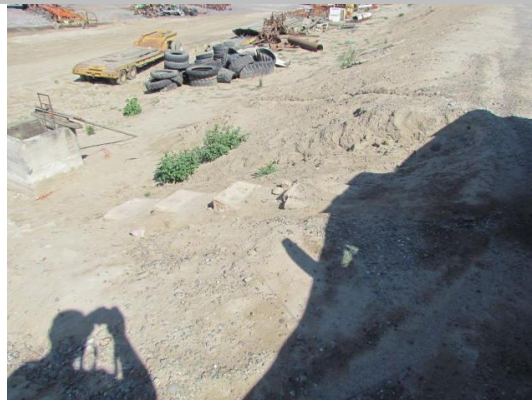
Photo 1 of 2 : FA\_2014\_RD0544\_108\_60\_20141020\_00028.jpg

Looking north at slope damage on landside slope.

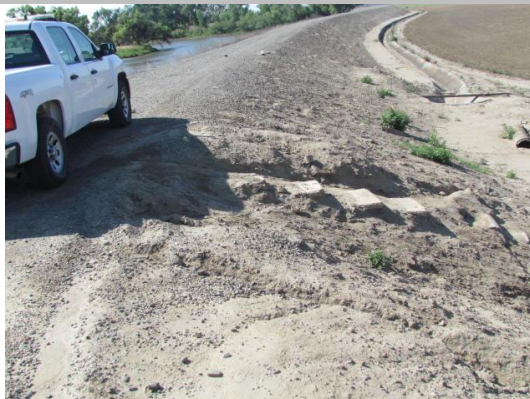
Photo 2 of 2 : FA\_2014\_RD0544\_108\_60\_20141020\_00029.jpg

Looking south at slope damage on landside slope.

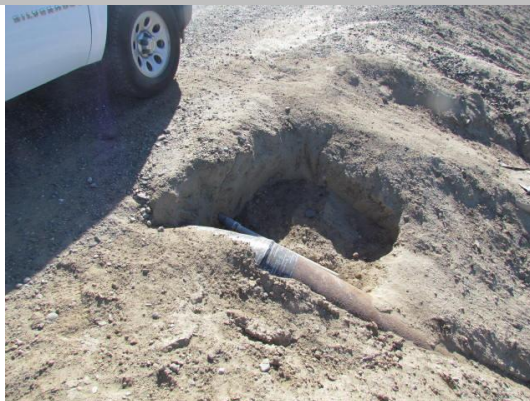
Photo 1 of 2 : FA\_2014\_RD0544\_108\_91\_20141023\_00062.jpg

Looking south at partially open trench around pipe on landward shoulder and slope.

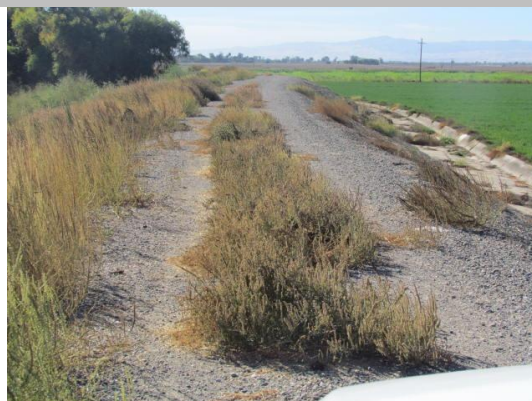
Photo 1 of 1 : FA\_2014\_RD0544\_108\_100\_20141023\_00063.jpg

Looking south at vegetation on levee crown.

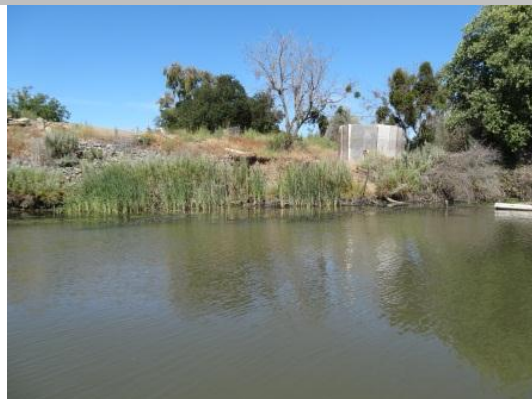
Photo 1 of 1 : SJR2014\_RD0544U01RM49.67\_1.jpg

Upstream view of the site.

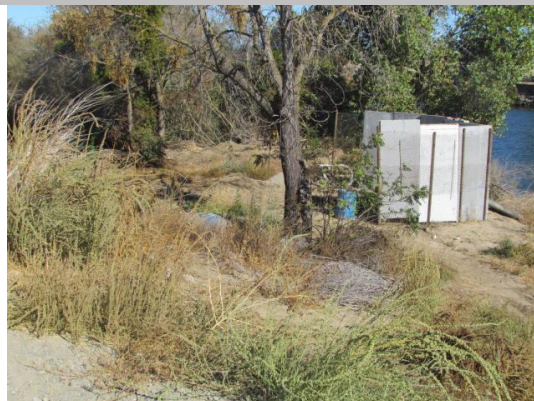
Photo 3 of 12 : FA\_2014\_RD0544\_108\_16\_20141023\_00068.jpg

Looking north at concrete wall on waterward berm.

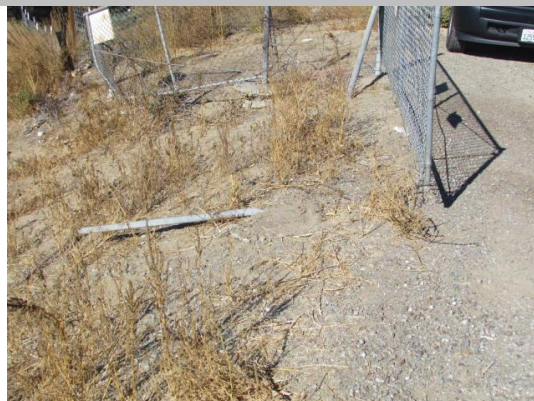
Photo 4 of 12 : FA\_2014\_RD0544\_108\_16\_20141023\_00069.jpg

Looking north at inch and half pipe at landward shoulder.

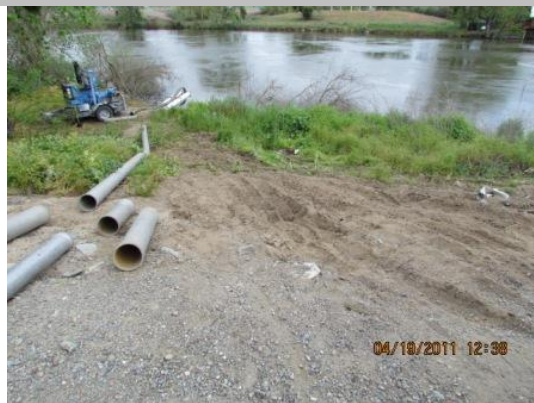
Photo 5 of 12 : FA\_2014\_RD0544\_108\_16\_20141020\_00008.jpg

Looking east at landowner installing temporary pump system without permit and damage to waterside slope.

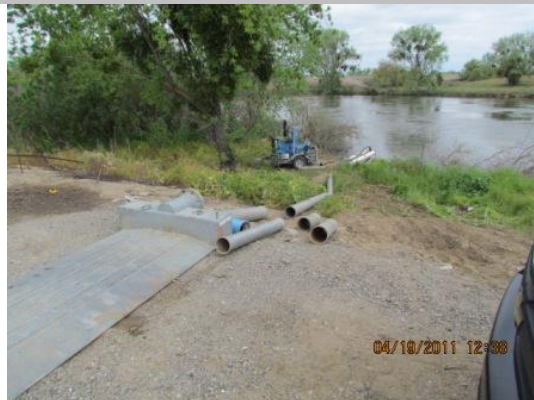
Photo 6 of 12 : FA\_2014\_RD0544\_108\_16\_20141020\_00009.jpg

Looking east at pump and irrigation ramp on levee waterside and crown.

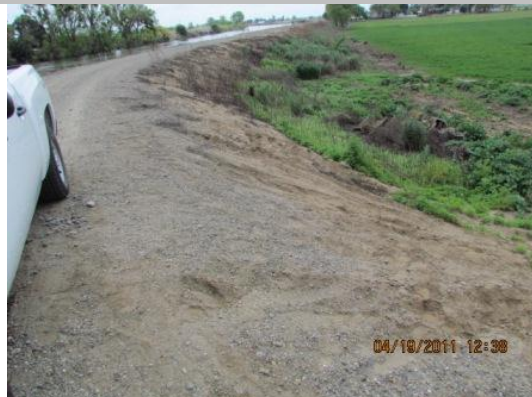
Photo 7 of 12 : FA\_2014\_RD0544\_108\_16\_20141020\_00010.jpg

Looking south at damage landside slope caused by vehicle traffic.

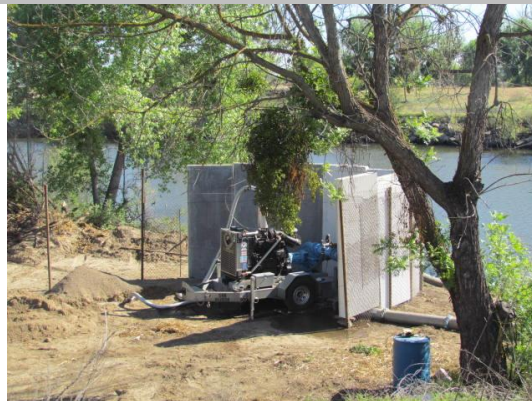
Photo 8 of 12 : FA\_2014\_RD0544\_108\_16\_20141020\_00011.jpg

Looking east at concrete wall around temporary pump on waterward berm. (Spring 2014)

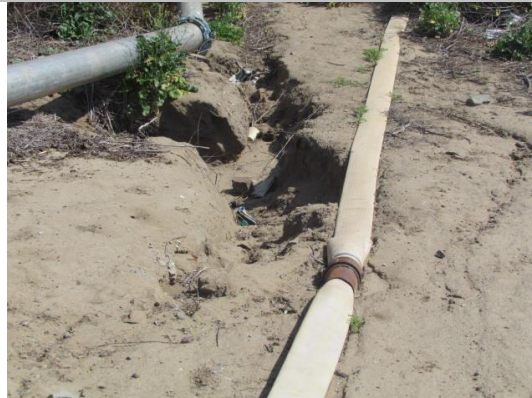
Photo 9 of 12 : FA\_2014\_RD0544\_108\_16\_20141020\_00012.jpg

Looking east at erosion caused by leaking pipe on waterside slope.

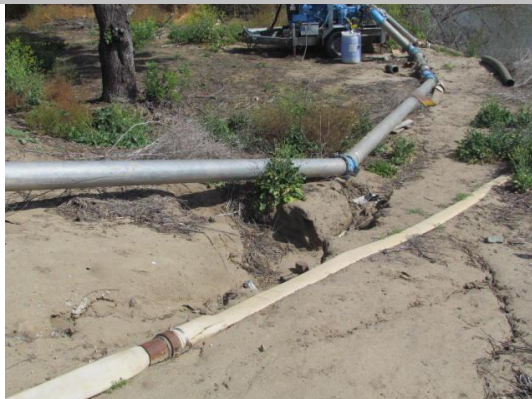
Photo 10 of 12 : FA\_2014\_RD0544\_108\_16\_20141020\_00013.jpg

Looking northeast at unauthorized pump system on waterside slope.

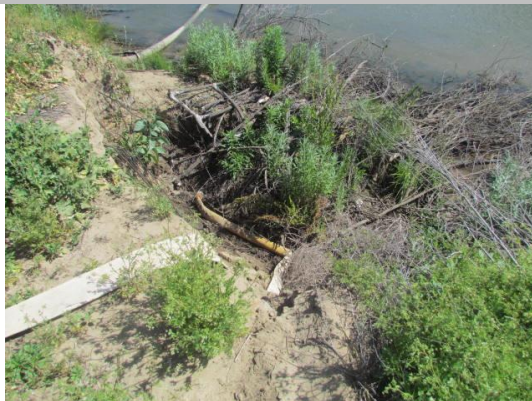
Photo 11 of 12 : FA\_2014\_RD0544\_108\_16\_20141020\_00014.jpg

Looking east at erosion caused by leaking hose on waterward berm.  
(Spring 2013)

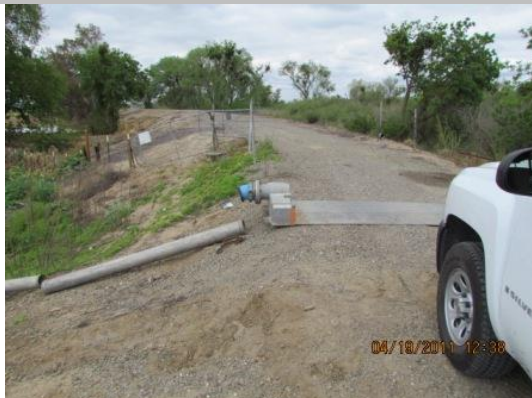
Photo 12 of 12 : FA\_2014\_RD0544\_108\_16\_20141020\_00015.jpg

Looking north at pipe and pipe ramp on landside and crown of levee.

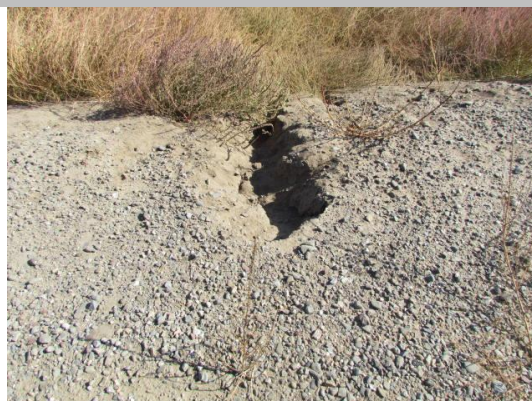
Photo 1 of 1 : FA\_2014\_RD0544\_108\_76\_20141020\_00038.jpg

Looking east at slope damage on waterward slope.

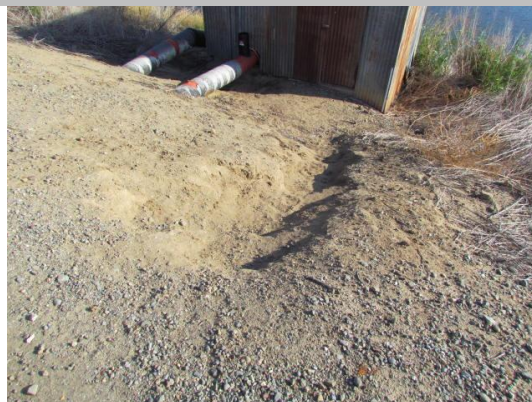
Photo 1 of 1 : FA\_2014\_RD0544\_108\_62\_20141020\_00030.jpg

Looking east at slope damaged by foot traffic near pump house on waterside of levee.

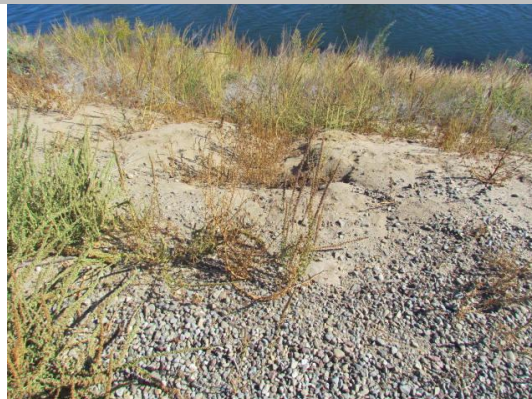
Photo 1 of 1 : FA\_2014\_RD0544\_108\_50\_20141023\_00071.jpg

Looking east at erosion on waterward slope.

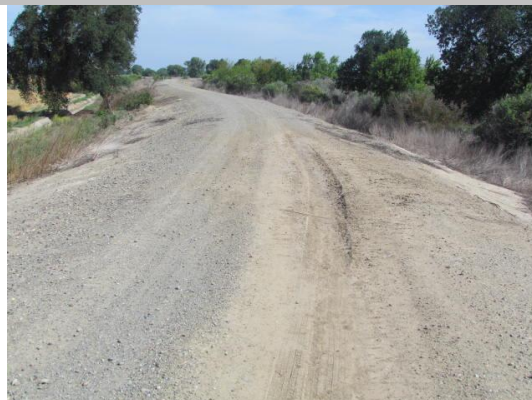
Photo 1 of 1 : FA\_2014\_RD0544\_108\_63\_20141020\_00031.jpg

Looking south at one of several sites needing gravel or road base on levee crown.

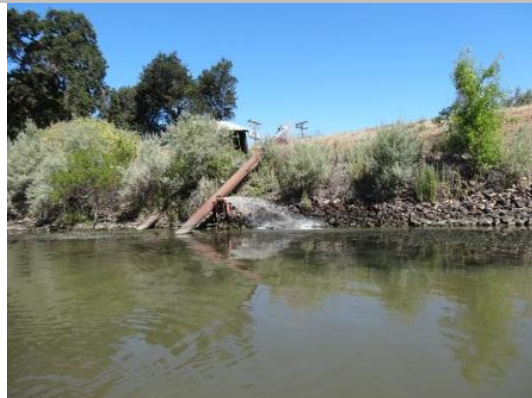
Photo 1 of 1 : SJR2014\_RD0544U01RM51.04\_1.jpg

View from upstream of the site.

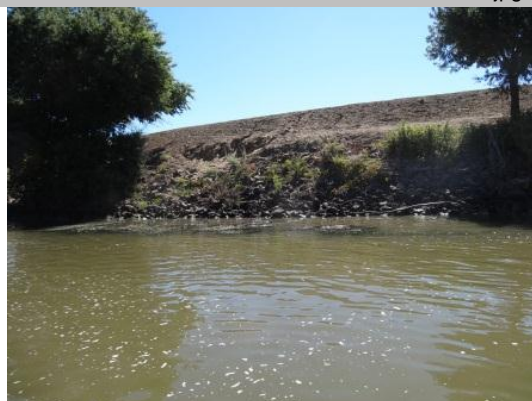
Photo 1 of 1 : SJR2014\_RD0544U01RM51.09\_1.jpg

View from downstream.

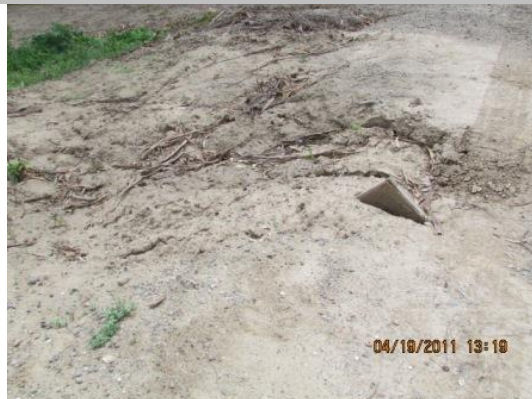
Photo 1 of 2 : FA\_2014\_RD0544\_108\_58\_20141020\_00026.jpg

Looking southeast at depression on waterside shoulder.

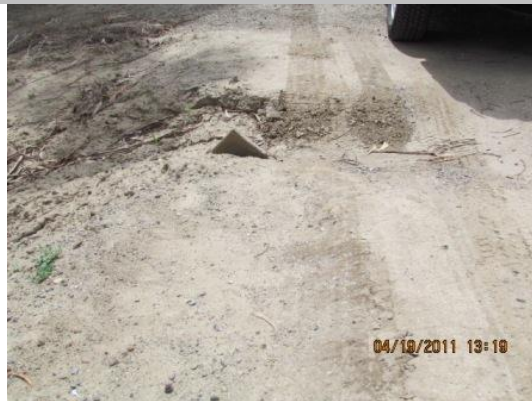
Photo 2 of 2 : FA\_2014\_RD0544\_108\_58\_20141020\_00027.jpg

Looking south at depression greater than 6" on waterside shoulder.

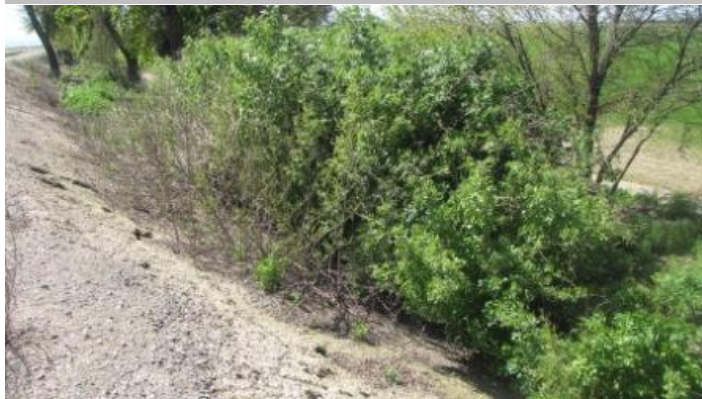
Photo 1 of 1 : FA\_2014\_RD0544\_108\_41\_20141020\_00023.jpg

Looking south at elderberries on landside slope and toe.

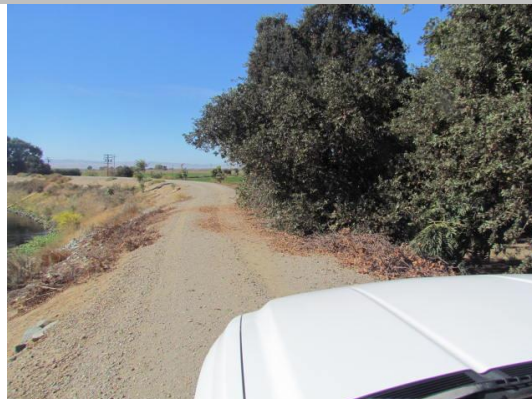
Photo 1 of 1 : FA\_2014\_RD0544\_108\_105\_20141023\_00072.jpg

Looking south at overgrown tree on landward shoulder.

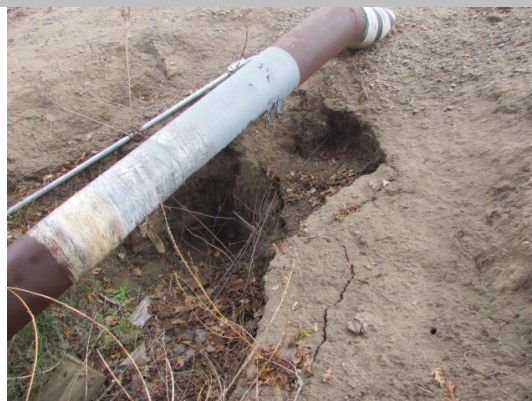
Photo 1 of 2 : FA\_2014\_RD0544\_108\_28\_20141020\_00020.jpg

Looking northeast at erosion around irrigation pipe on landside slope.

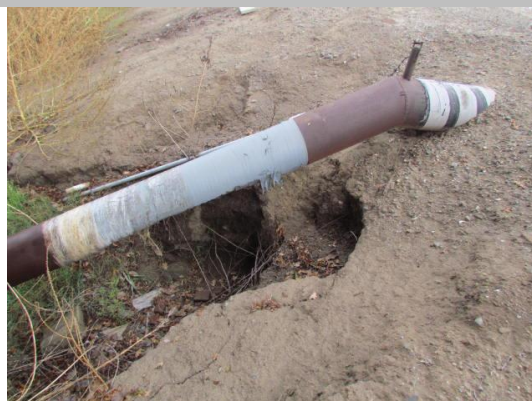
Photo 2 of 2 : FA\_2014\_RD0544\_108\_28\_20141020\_00021.jpg

Looking north at erosion around irrigation pipe on landside

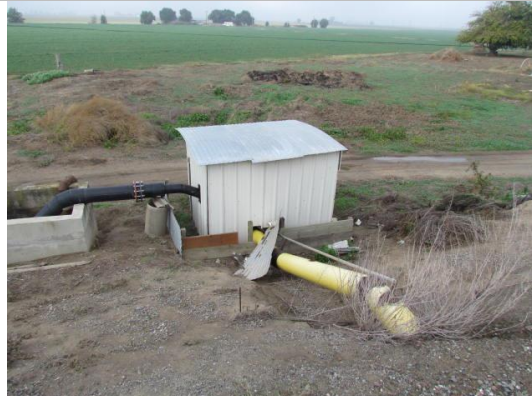
Photo 1 of 1 : FA\_2014\_RD0544\_108\_45\_20141020\_00024.jpg

Looking west at a unauthorized pump house on landside toe.

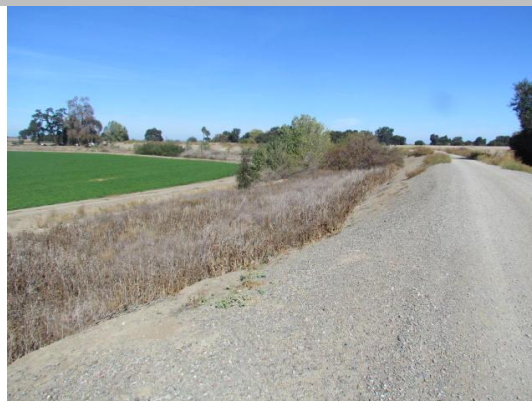
Photo 1 of 3 : FA\_2014\_RD0544\_108\_33\_20141023\_00073.jpg

Looking north at dead vegetation still blocking landward toe.

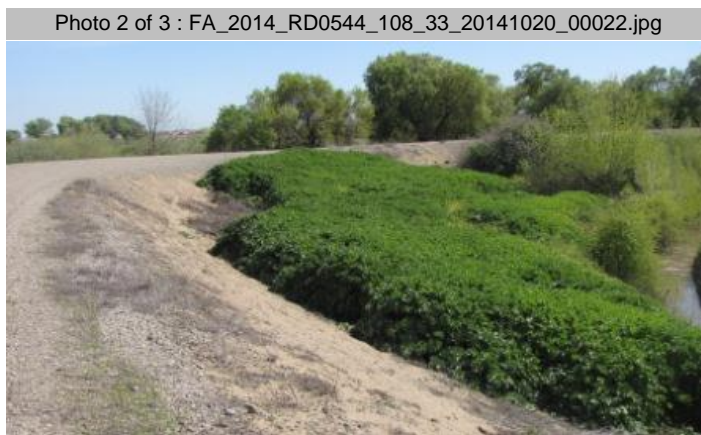
LM Start	5.00	Rating **	M	Issue No.	33 (cont)
LM End	5.30	Issue Type +	Ma	Location *	LS
Category	Earthen Levee			GPS Latitude/Longitude	
				Start	End
Item	Vegetation			37.818718 °	37.814662 °
				-121.319508 °	-121.320302 °
DWR ID	DWR_RD0544_01_s_2012_33				
Action/Comments					
Remove the wild growth other than native grasses from the levee slopes.					
Inspector Comments: Vegetation has been sprayed, but still blocking view of landward toe.

Looking southeast at dense veg. on landside slope and toe.

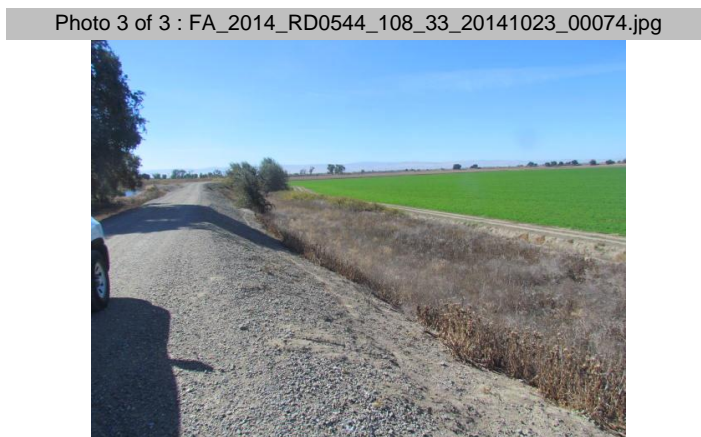
Looking south at dead vegetation still blocking landward toe.

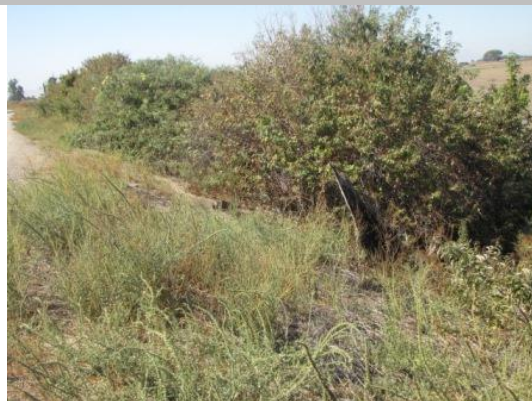
Photo 1 of 2 : FA\_2014\_RD0544\_108\_18\_20141020\_00016.jpg

Looking south at elderberries on landside slope and toe.

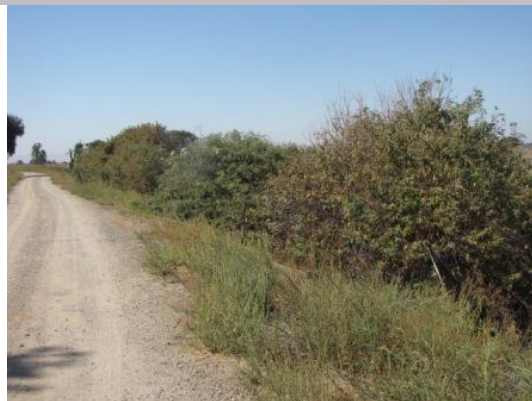
Photo 2 of 2 : FA\_2014\_RD0544\_108\_18\_20141020\_00017.jpg

Looking southwest on elderberries on landside slope and toe.

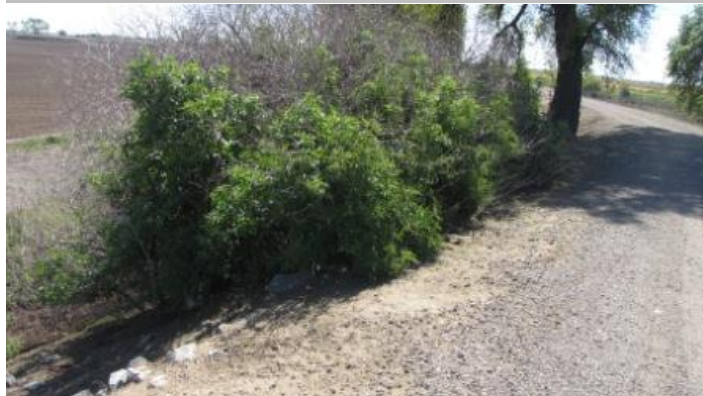
Photo 1 of 3 : FA\_2014\_RD0544\_109\_4\_20141020\_00001.jpg

Looking northwest at elderberries on landside slope and toe.

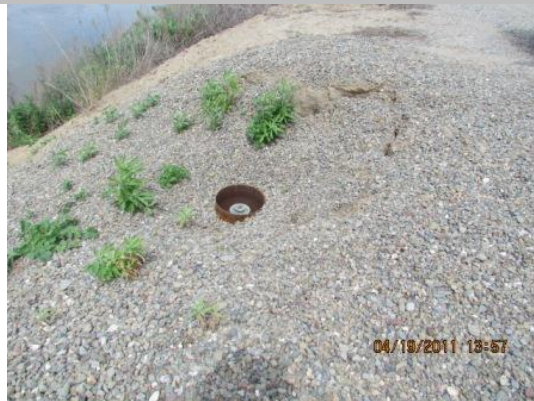
Photo 3 of 8 : FA\_2014\_RD0544\_109\_8\_20141020\_00008.jpg

Looking south at depression greater than 6" on waterside shoulder.

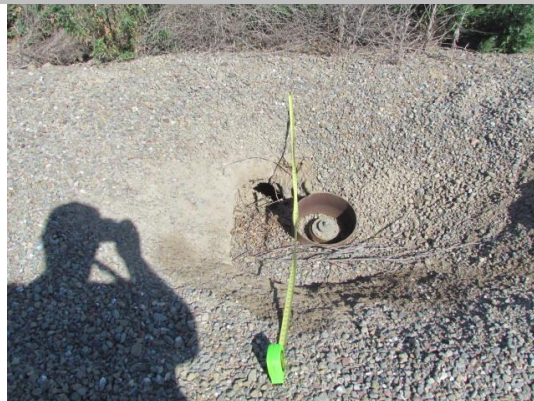
Photo 4 of 8 : FA\_2014\_RD0544\_109\_8\_20141020\_00009.jpg

Looking east at caving around siphon on waterside shoulder. (Spring 2012)

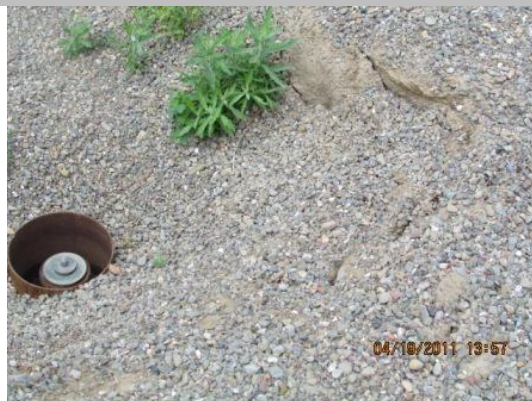
Photo 5 of 8 : FA\_2014\_RD0544\_109\_8\_20141020\_00010.jpg

Looking at top of siphon with a depression greater than 6" on waterside shoulder.

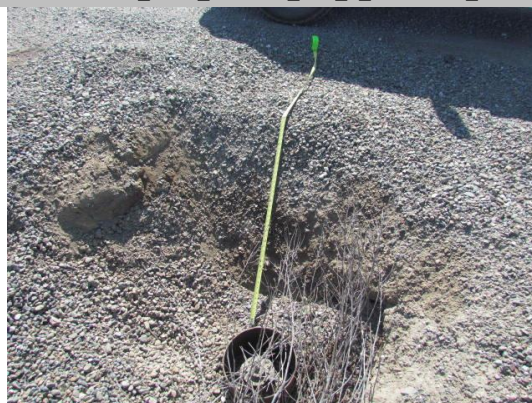
Photo 6 of 8 : FA\_2014\_RD0544\_109\_8\_20141020\_00011.jpg

Looking west at caving around siphon on waterside shoulder. (Spring 2012)

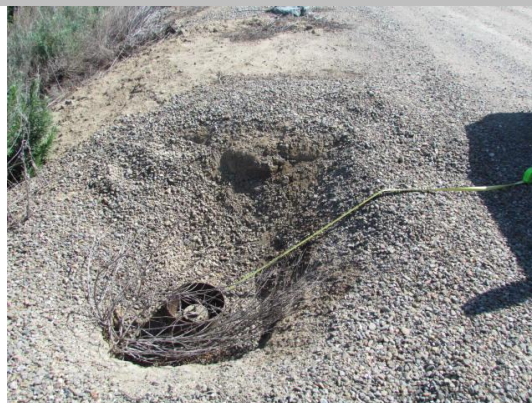
Photo 7 of 8 : FA\_2014\_RD0544\_109\_8\_20141020\_00012.jpg

Looking south at caving around siphon on waterside shoulder. (Spring 2012)

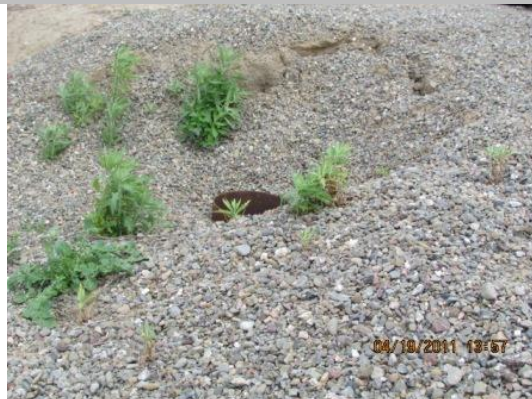
Photo 8 of 8 : FA\_2014\_RD0544\_109\_8\_20141020\_00013.jpg

Looking south at depression greater than 6" around siphon on waterside shoulder.

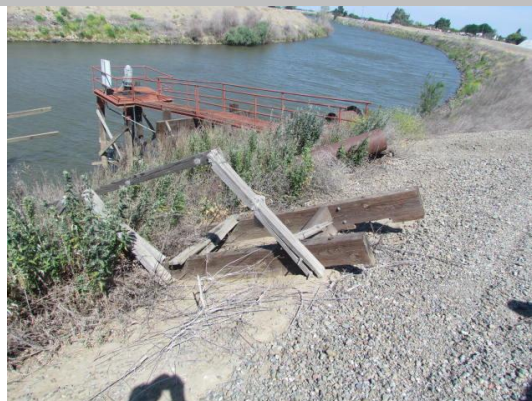
Photo 1 of 1 : FA\_2014\_RD0544\_109\_6\_20141020\_00005.jpg

Looking southeast at garbage on waterside shoulder and slope.

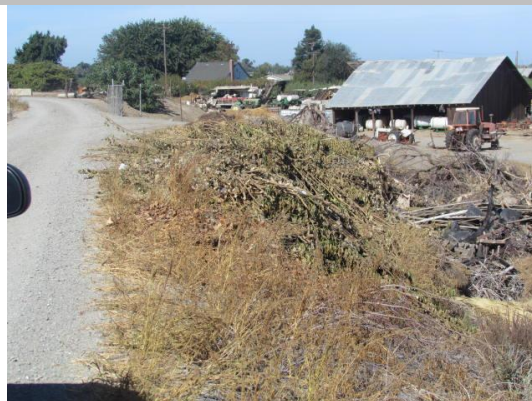
Photo 1 of 4 : FA\_2014\_RD0544\_109\_20\_20141023\_00048.jpg

Looking southwest at trash and pruning pile on landward shoulder and slope.

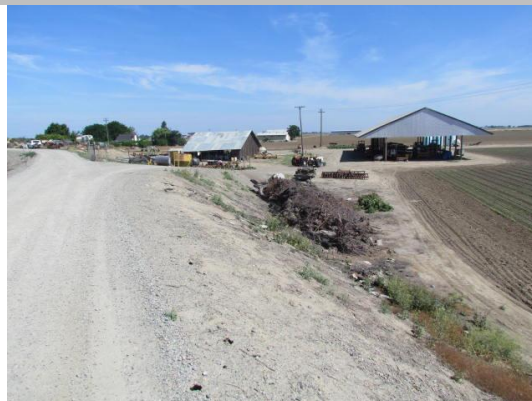
Photo 4 of 4 : FA\_2014\_RD0544\_109\_20\_20141020\_00026.jpg

Looking southwest at garbage and pruning pile at landside toe. (Spring 2012)

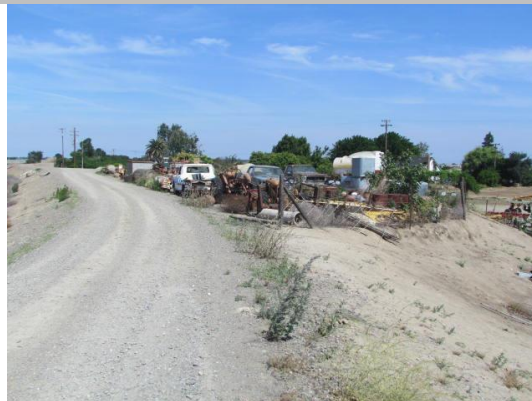
Photo 2 of 3 : FA\_2014\_RD0544\_109\_18\_20141020\_00021.jpg

Looking southwest at vehicles and farm equipment stored on landside landing.

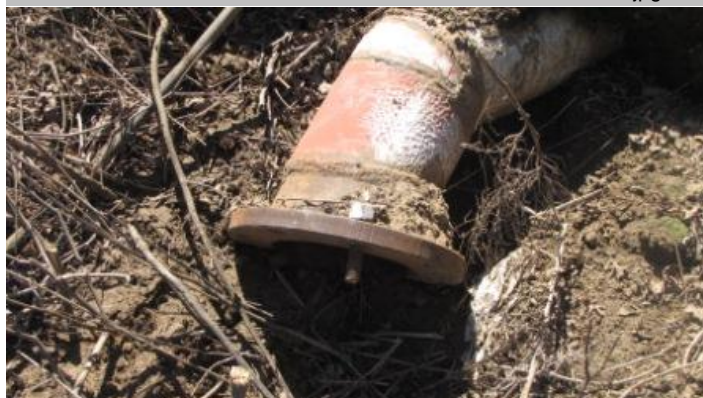
Photo 1 of 3 : FA\_2014\_RD0544\_109\_21\_20141020\_00027.jpg

Looking east at pipe on landside slope.

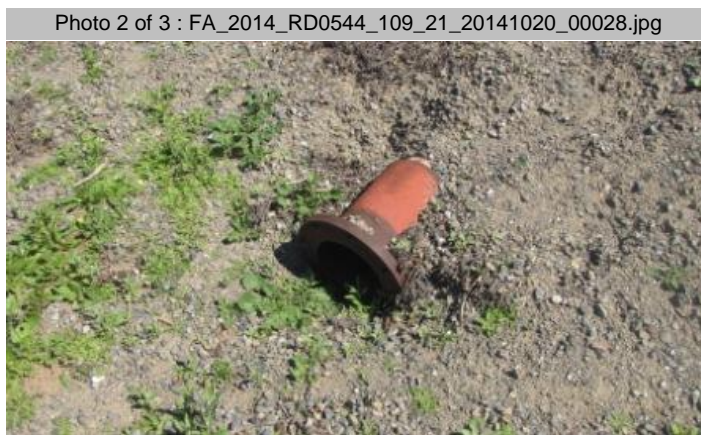
Looking west at east end of pipe on waterside slope.

LM Start	1.40	Rating **	A/W	Issue No.	21 (cont)
LM End	1.40	Issue Type +	En	Location *	LS
Category	Earthen Levee			GPS Latitude/Longitude	
				Start	End
Item	Encroachments			37.821463 °	37.821463 °
				-121.337900 °	-121.337900 °
DWR ID	DWR_RD0544_02_s_2012_21				
Action/Comments					
Pipe					
Inspector Comments: Pipe should be removed or properly abandoned.

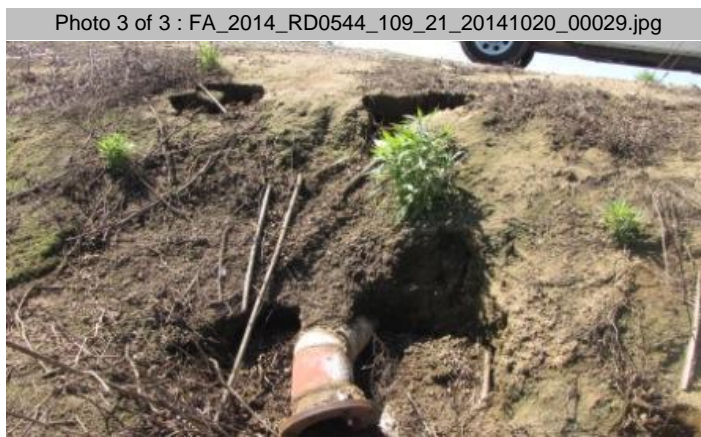
Looking east at pipe and erosion just above pipe on landside slope and shoulder.

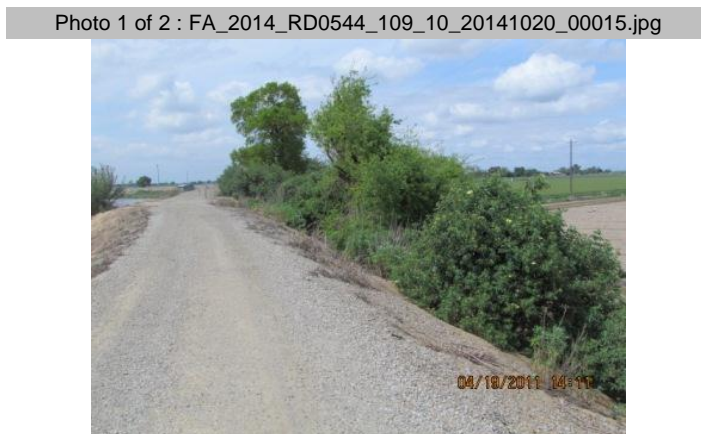
LM Start	1.41	Rating **	U	Issue No.	10
LM End	1.41	Issue Type +	Ma	Location *	LS
Category	Earthen Levee			GPS Latitude/Longitude	
				Start	End
Item	Vegetation			37.821423 °	37.821423 °
				-121.337878 °	-121.337878 °
DWR ID	DWR_RD0544_02_s_2012_10				
Action/Comments					
Elderberries are blocking visibility and flood fight capability.

Looking southwest at elderberries on landside slope.

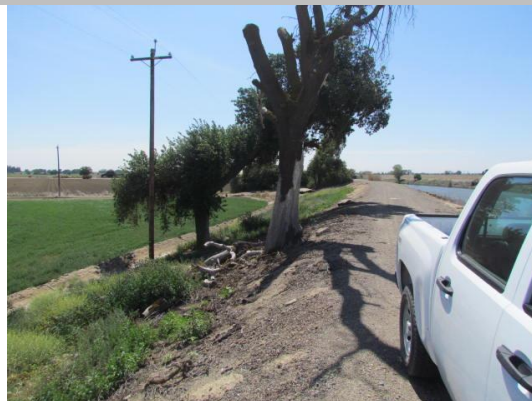
Photo 1 of 1 : FA\_2014\_RD0544\_109\_23\_20141020\_00031.jpg

Looking north at dead tree and tree limbs on landside shoulder and slope.

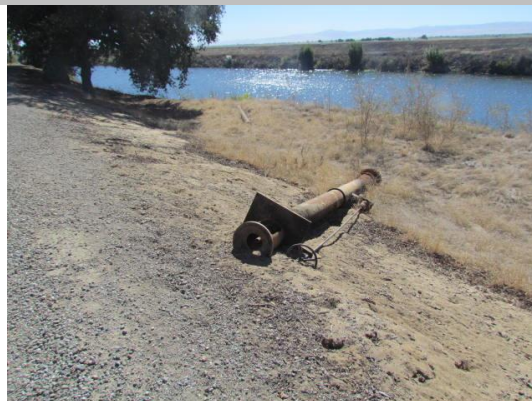
Photo 1 of 1 : FA\_2014\_RD0544\_109\_50\_20141023\_00052.jpg

Looking northwest at pipe on waterward slope.

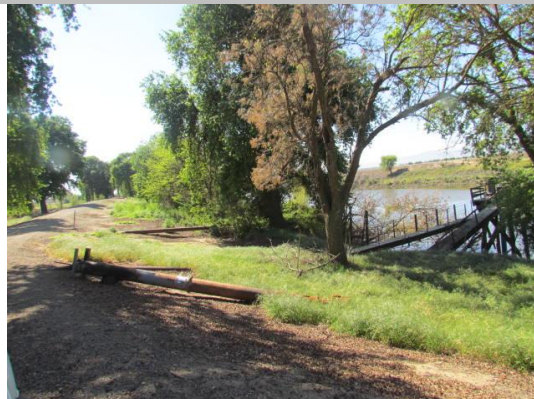
Photo 1 of 1 : FA\_2014\_RD0544\_109\_51\_20141020\_00038.jpg

Looking north at old pump shaft and pipe on waterward slope.

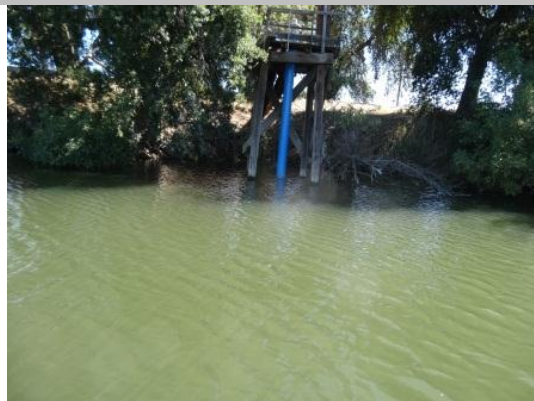
Photo 1 of 1 : SJR2014\_RD0544U02RM33.21\_1.jpg

Front view of the erosion site. View is partially blocked by the pump structure and vegetation.

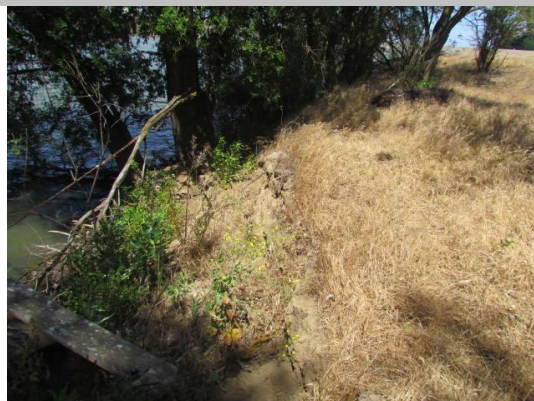
Photo 2 of 3 : FA\_2014\_RD0544\_109\_24\_20141020\_00033.jpg

Looking south at river erosion at waterside toe near pumping station.

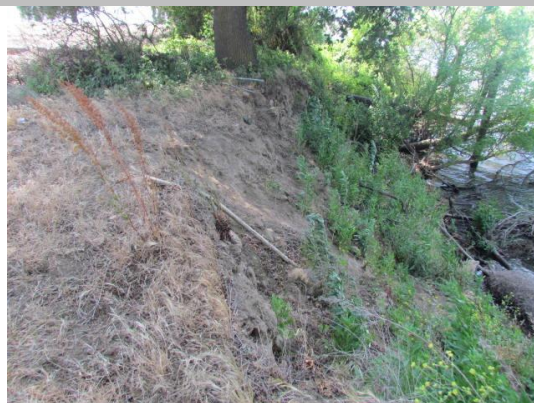
Photo 3 of 3 : FA\_2014\_RD0544\_109\_24\_20141020\_00034.jpg

Looking north at erosion on waterside slope.

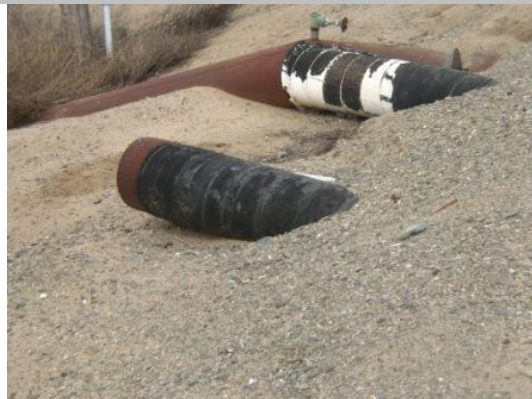
Photo 1 of 1 : FA\_2014\_RD0544\_109\_15\_20141020\_00019.jpg

Abandoned pipe at LM 2.65, landside view.

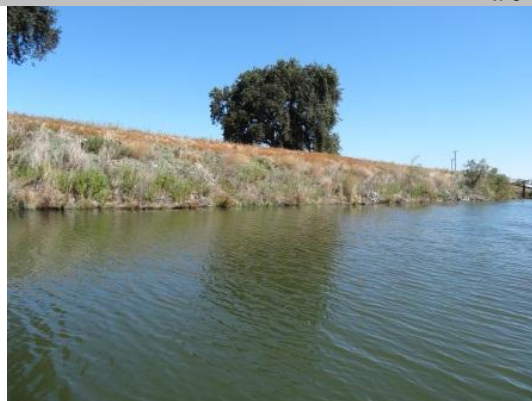
Photo 1 of 1 : SJR2014\_RD0544U02RM32.91\_1.jpg

Front view of pocket erosion. Note the vegetation and riprap at the site.

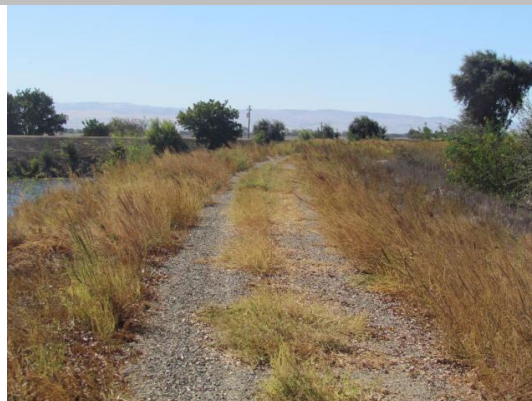
Photo 1 of 1 : FA\_2014\_RD0544\_109\_52\_20141023\_00053.jpg

Looking south at vegetation on levee crown.

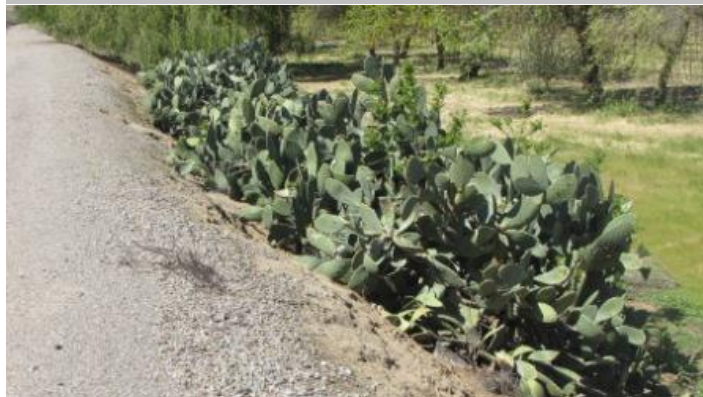
Photo 2 of 2 : FA\_2014\_RD0544\_109\_36\_20141020\_00036.jpg

Looking southwest at overgrown cactus on landside slope.
